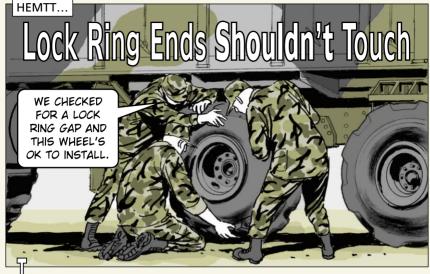
TM 9-2320-279-10's after-operation PMCS, various warnings in TM 9-2320-279-20-1 and -20-2. and maintenance procedures in the -20-2 all say that lock ring ends must not gap more than 3/8 inch. But the width of the gap is not as important as making sure there **IS** a gap.

If the lock ring ends touch on any HEMTT wheel, including the spare, your truck is NMC until the wheel is repaired.

For the whole story, get copies of TACOM Ground Precautionary Messages (GPM) 99-08, 00-002 and 00-003 from your local safety office or logistics assistance office. TM changes are scheduled to be made in the next revision or update.
